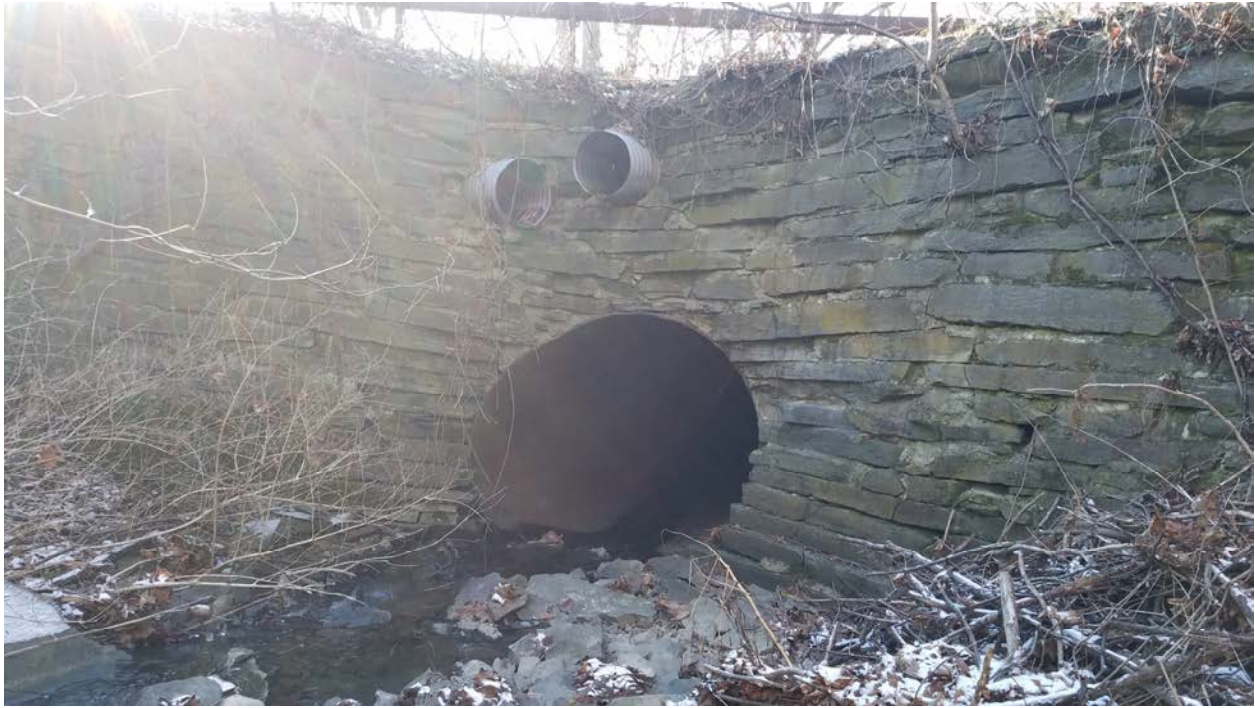
Photo #1 – Inlet side with laid up stone headwall

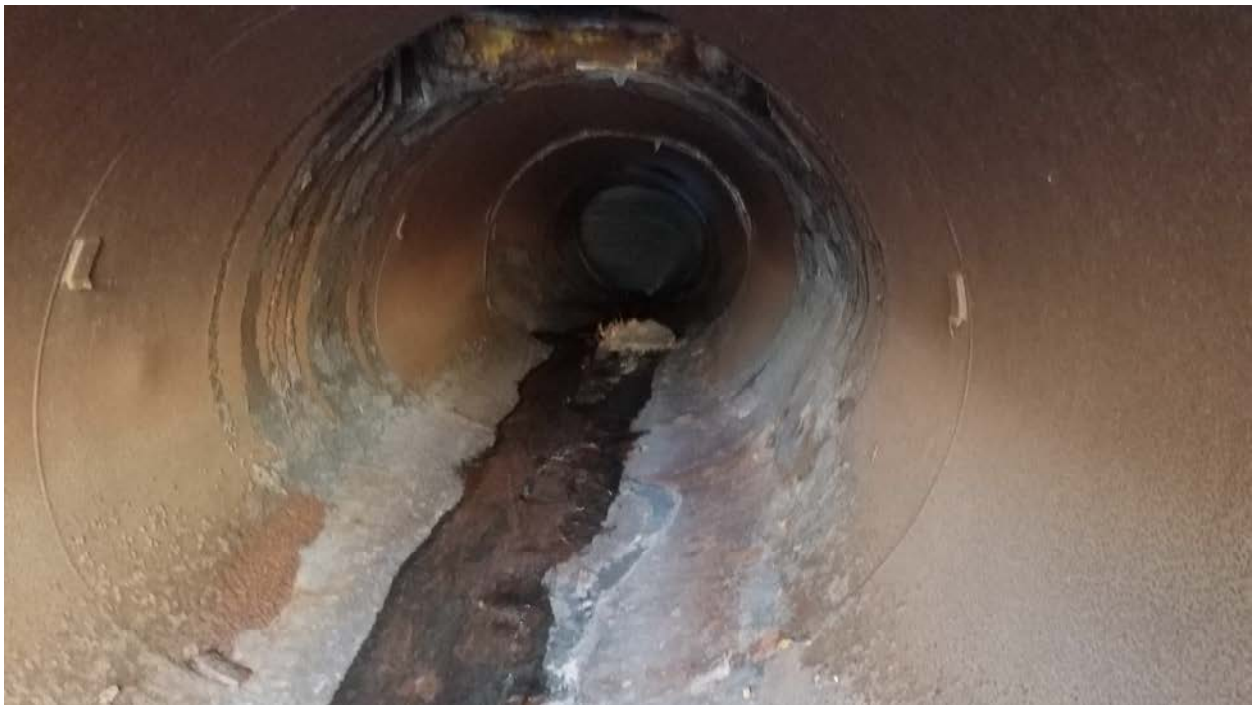
Photo #2 – Looking Downstream From Inlet of Structure – Pipe failure at top of pipe

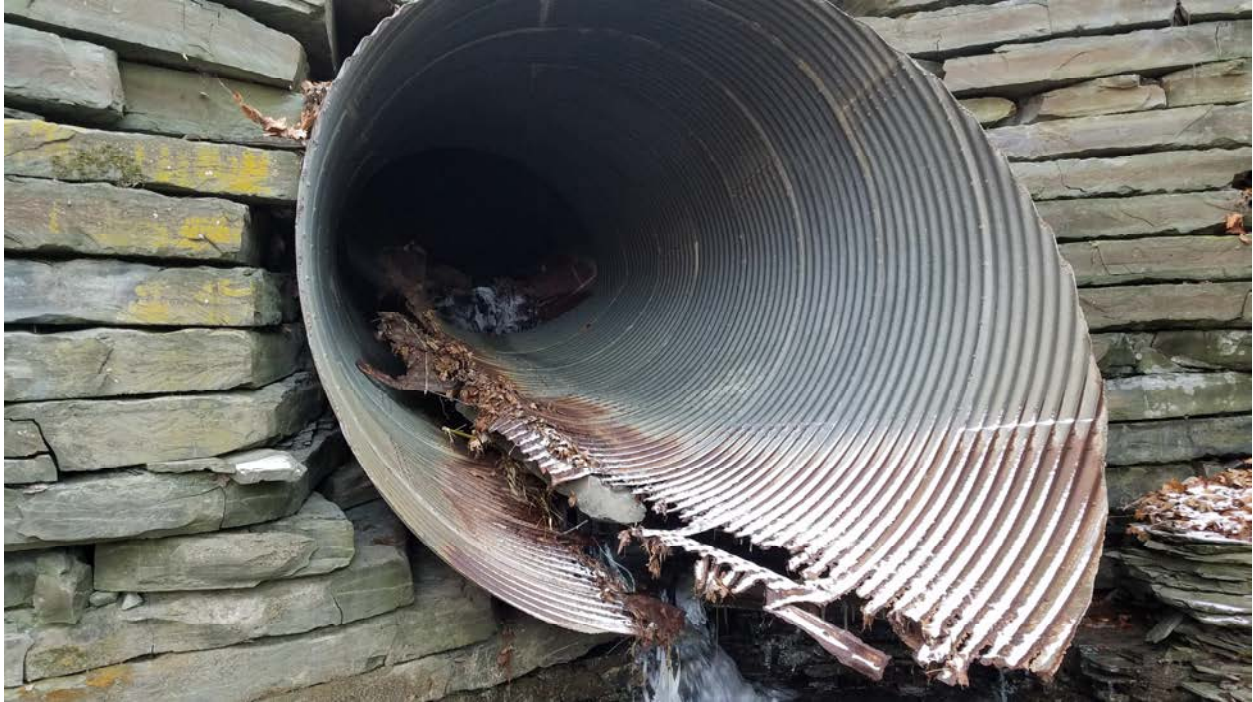
Photo #3 – Outlet End of Pipe – Rotted pipe folding in on itself

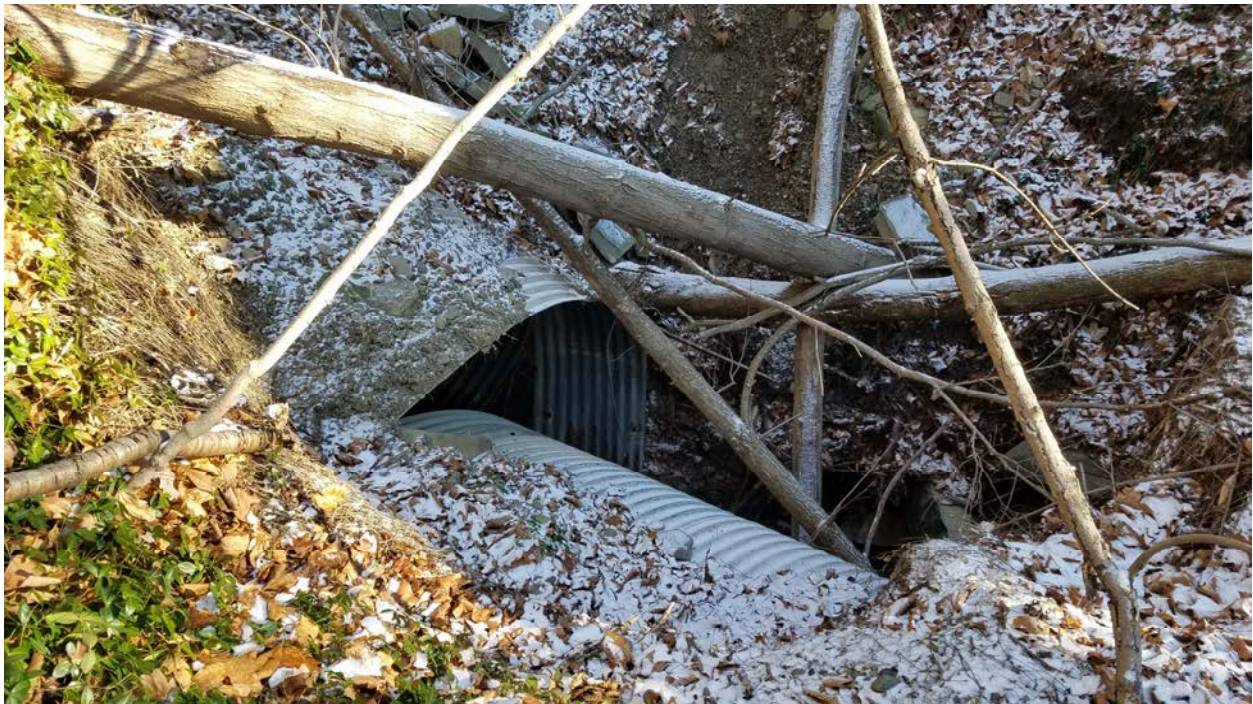
Photo #4 – Outlet End of Pipe – Separation of last length of pipe and second to last length of pipe

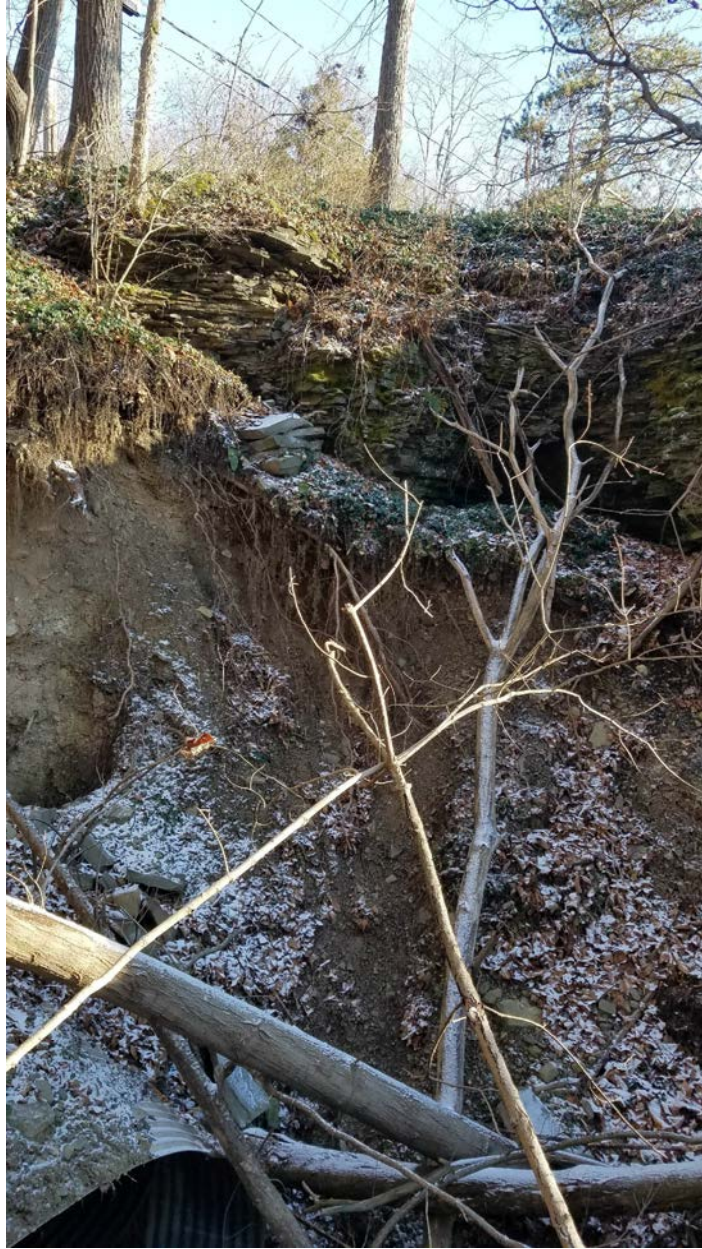
Photo #5 – Outlet End – Erosion of surrounding area near pipe separation in Photo #4

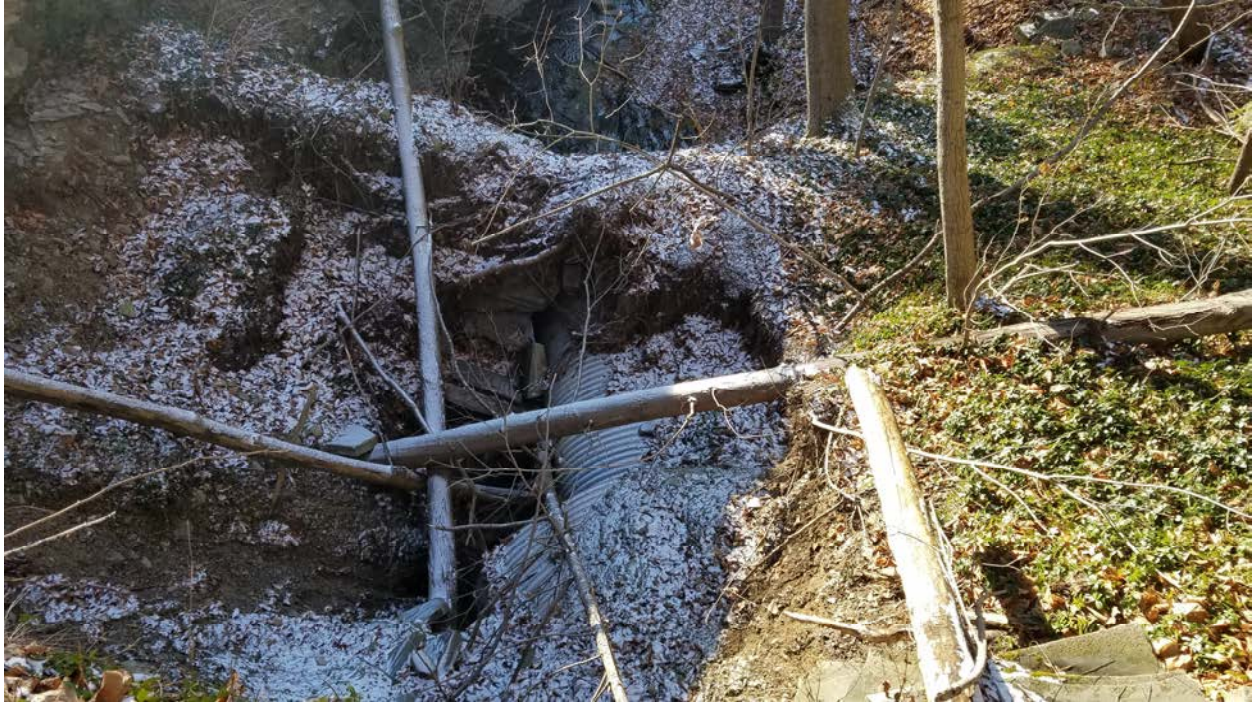
Photo #6 – Looking downstream from road of erosion at pipe separation in Photo #4

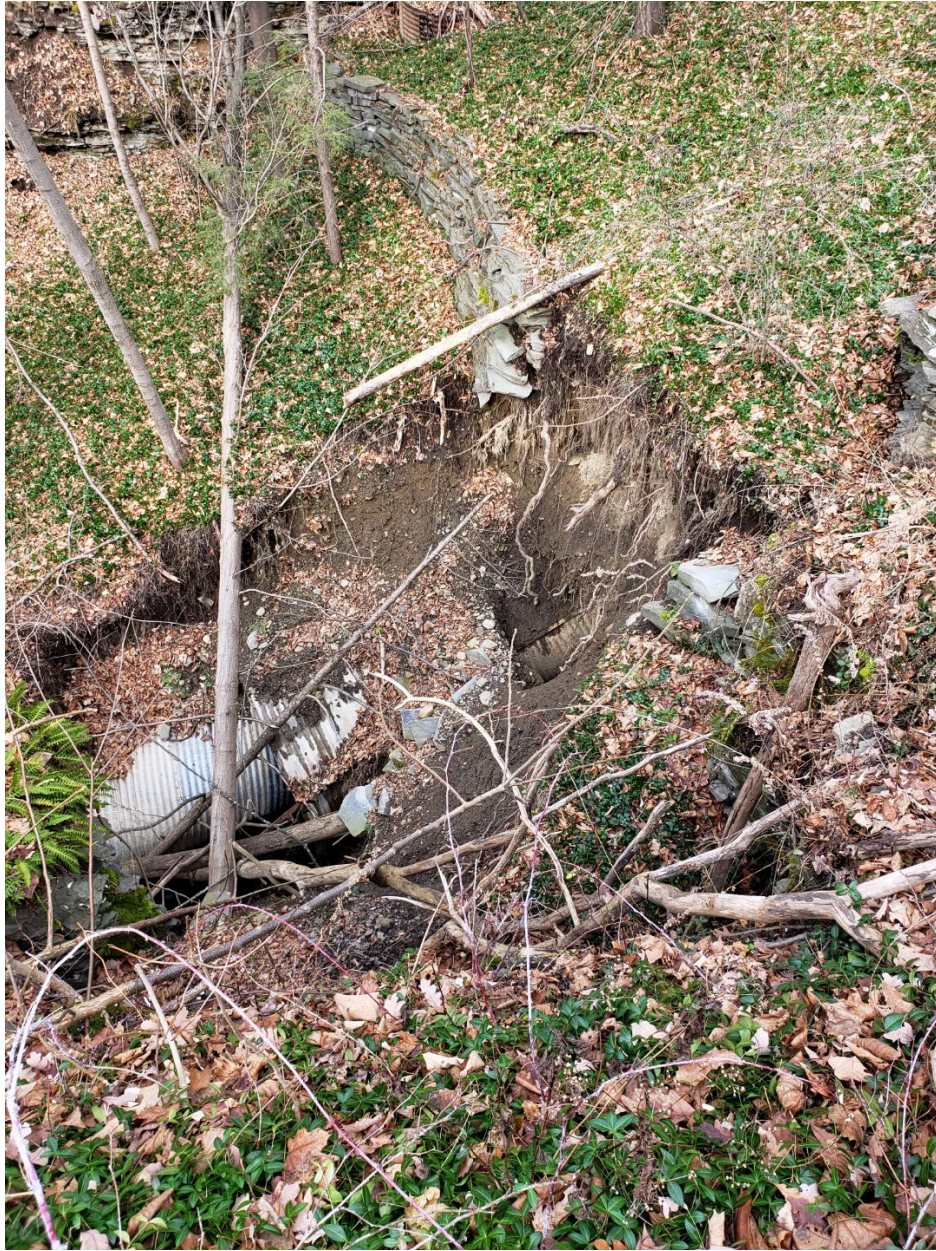
Photo #9 – Looking north at the outlet end of separation in Photo #4.
