# Cayuga Heights Village Hall

836 Hanshaw Road, Cayuga Heights, New York

## Historic Structure Report

Tamara Pilson

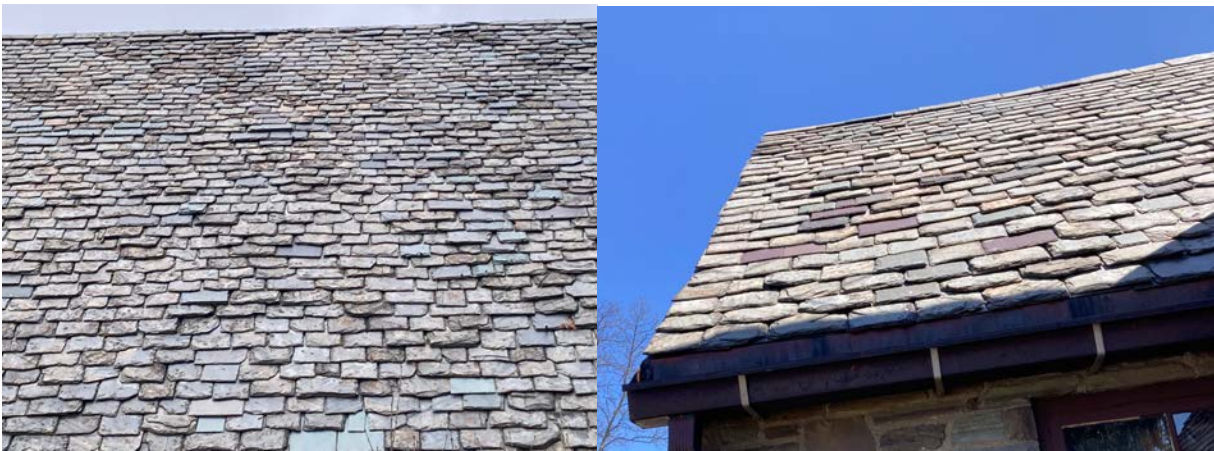
Slate shingle condition along the southeast elevation of Section F (L) and the southwest elevation of Section C (R), showing delamination and the piecemeal addition of new shingles.

The roof is in overall fair condition and, importantly, has not had any reported issues with leaking. Over time, however, many slate tiles have fallen or popped off or otherwise needed to be replaced. The most common cause of this has been moisture infiltration coming from the interior or up from the walls, which causes bulging of the ceiling plaster and/or of the sheathing beneath the tiles, which in turn pops the tiles off from their attachments. The village hall has a stock of slate tiles for replacement where needed and does so in piece-meal fashion rather than replacing the roof wholesale. The new slate tiles don't always match in shape and can look discordant with the older tiles, which are often heavily delaminated and eroded around the edges.

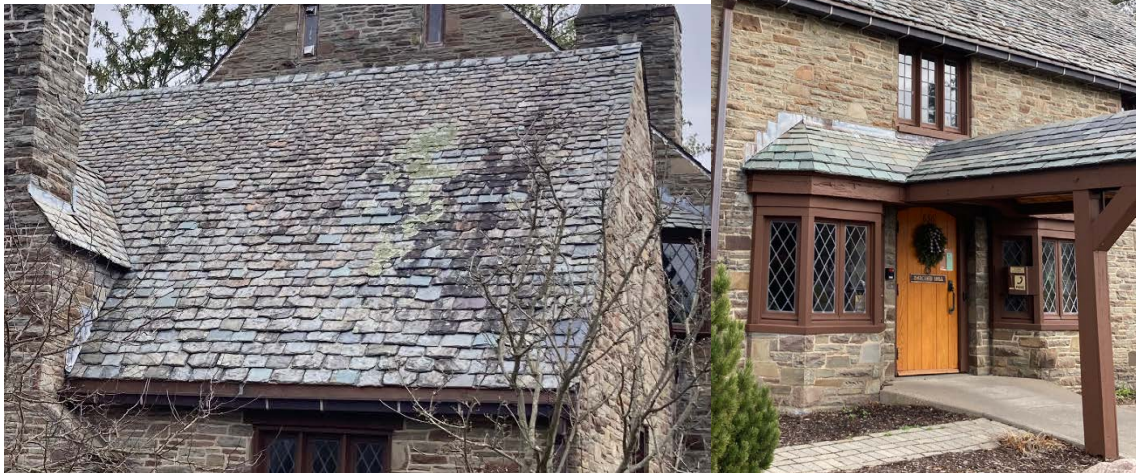
Black and green biological growth on the northwest roof of Section B (L). Rust stains on the shingles of the portico (R).

Some of the slate tiles have started to show signs of rust from the oxidation of the metal nails used to attach them. There are large patches of biological growth, namely on the northwest roof of Section B, where the growth appears in the form of green moss or lichen as well as black biological staining. There are lots of pine needles and other organic detritus between the slates of the northeast slope of the hyphen, and many of its tiles are stained green from biological growth.

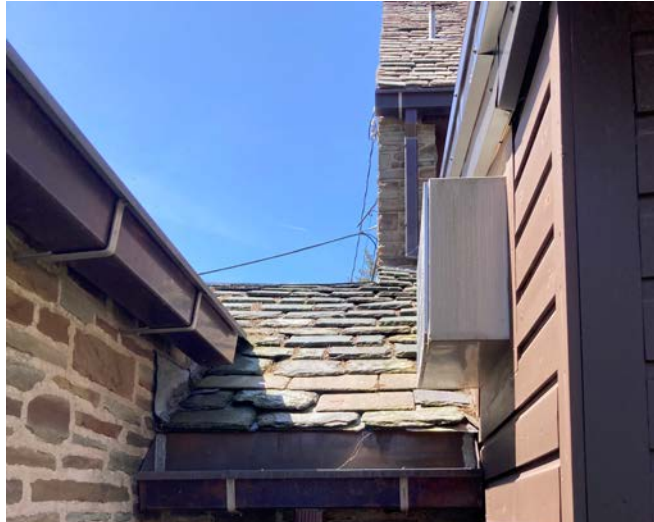
Accumulated biological detritus and yellow-green biological growth on the northeast roof of the hyphen.

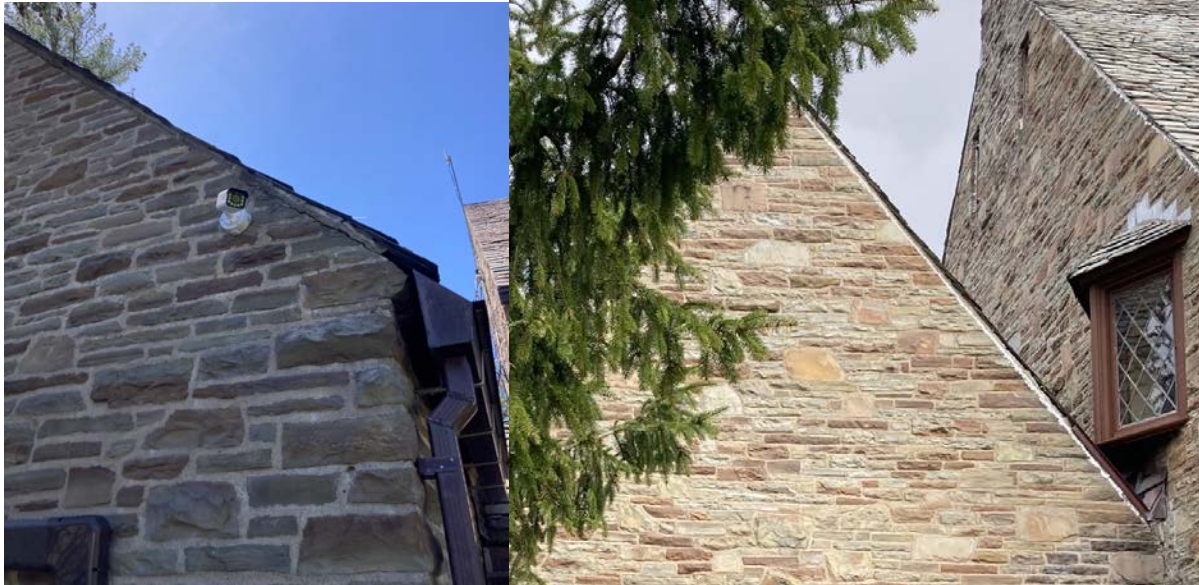
Mortar joint separation between the wall and roof on the northeast wall of Section F (L) and the southwest wall of Section B (R).

On the gable ends, where the roof meets the wall, there is a thick band of mortar between them. In some locations, namely the northeast wall of section F, the mortar joints have started to crack and detach themselves from the stone wall, with clear fissures. Smaller cracks can be found on the northeast wall of Section B, where there are white inclusions at various points in the mortar that may be from former repointing or caulking efforts but which do not appear to attach well to the rest of the structure. Similar white lines along the mortar appear in better shape along the gable ends of Section A and the southwest elevation of Section B.

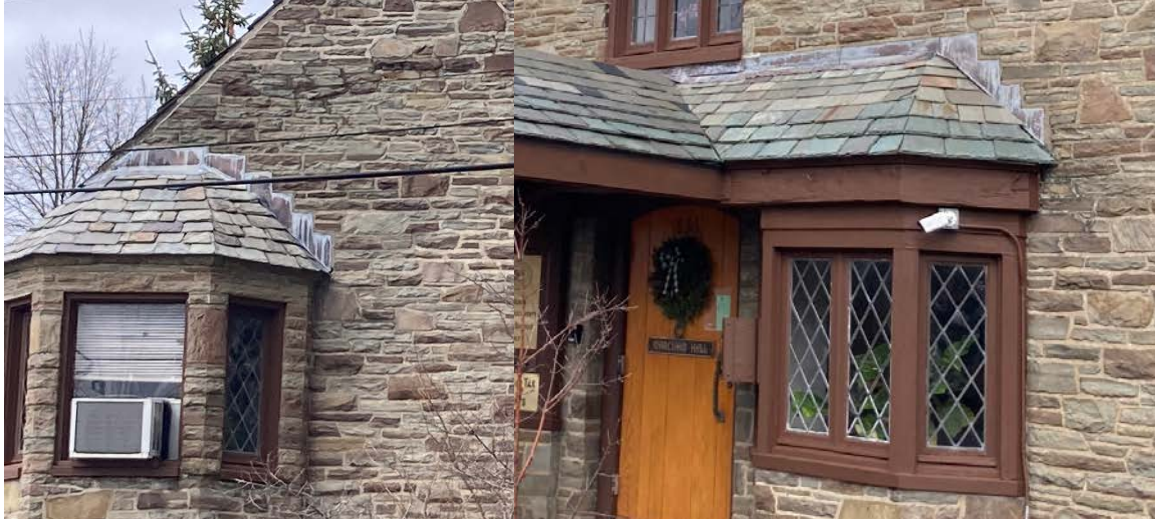
Rust on the flashing above the bay projection (L) and the portico (R).

The lead-coated copper used for flashing around the roof is heavily rust-stained and discolored in some parts, such as above the bay projection on the southeast and above the entrance portico.

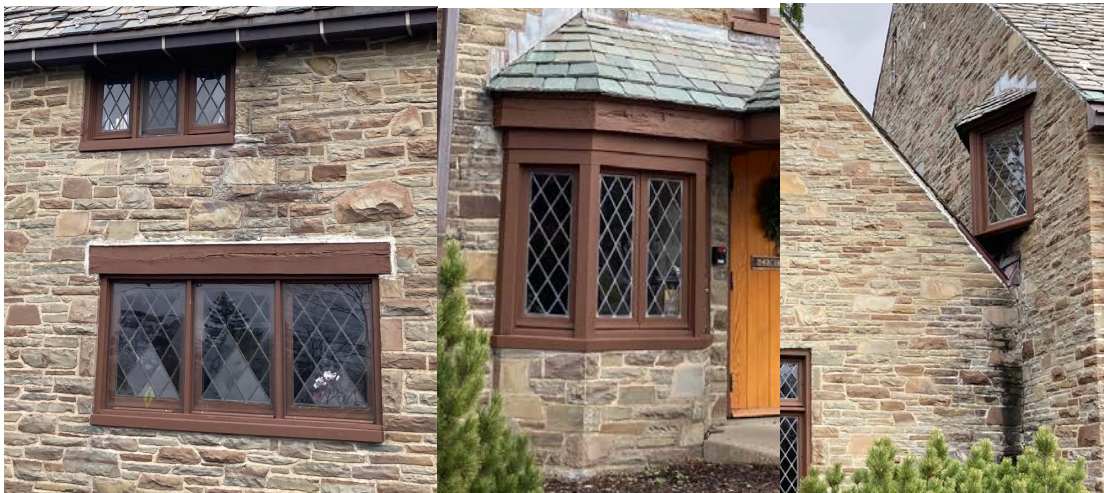
Moisture damage and staining between the eastern windows on Section A (L), next to the western oriel (C), and at the junction of Section A and B (R).

There was no gutter system for the building until the last five or six years, which means that there are some portions of the wall system suffering from severe moisture infiltration.

Prominent areas for visible moisture damage include the wall between easternmost windows on Section A's southwest elevation, up to the roofline; the wall next to the westernmost oriel on Section A; corner where Section A meets Section B; the northeast wall of the hyphen, especially in the corner where it attaches to section F; the chimney between B and C, especially below the coping stone, with damage that extends onto the adjacent wall of B; by the window on the southwest wall of C; and below the window on the northwest wall of C. This moisture damage consistently takes the form of dark black staining from water, salt deposits or efflorescence, and possible ensuing biological growth.

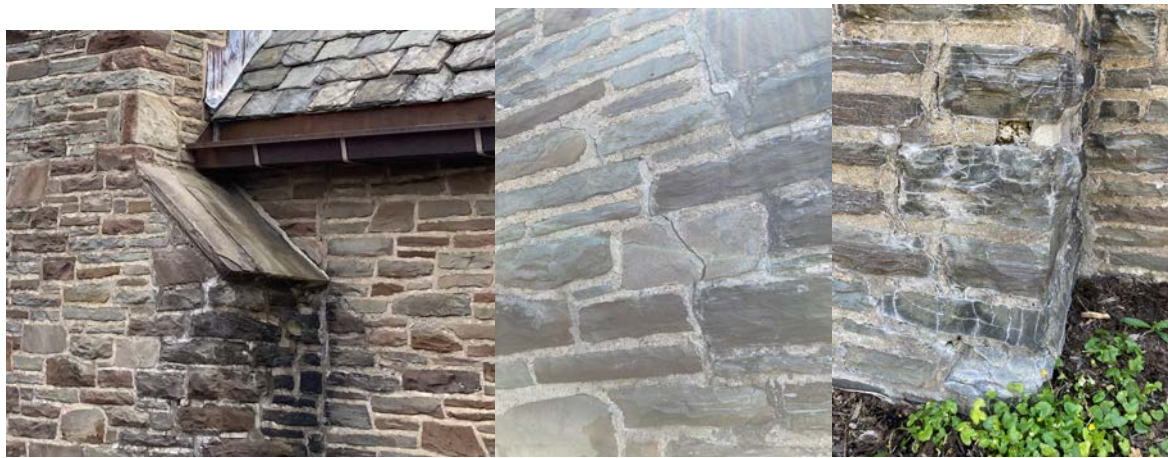
Moisture damage and staining (L), large cracks (C) missing mortar and stone and efflorescence striations (R), all on and around the chimney between Section B and C.

The chimney and wall area between B and C has white striations from salt leaching, as well as large chunks of missing mortar and loose or missing pieces of stone. This area also has large cracks suggesting movement.

Though there are no currently known issues with the building's structural stability, the large cracks around the walls and chimneys of Sections B and C should be measured and monitored for movement—it will be important to know whether they are simply aesthetic, surface-level cracks or indications of structural instability.

Repointing is needed in the mortar-damaged areas of Sections B and C, and for parts of all three chimneys. The kinds of sands used in the original mortar could be determined through laboratory testing, which combined with close analysis of the mortar itself could be used to select a compatible mortar that matches, to the greatest extent possible, the appearance and texture of the original mortar.<sup>16</sup> The new mortar should also be softer and more permeable than the stone units so that it does not end up damaging the masonry, and should be understood as sacrificial.

Patch repairs can be used to fix areas around Sections B and C where chunks of stone have fallen off, as well as for the spalling of the concrete chimney caps. Inside, the cracking

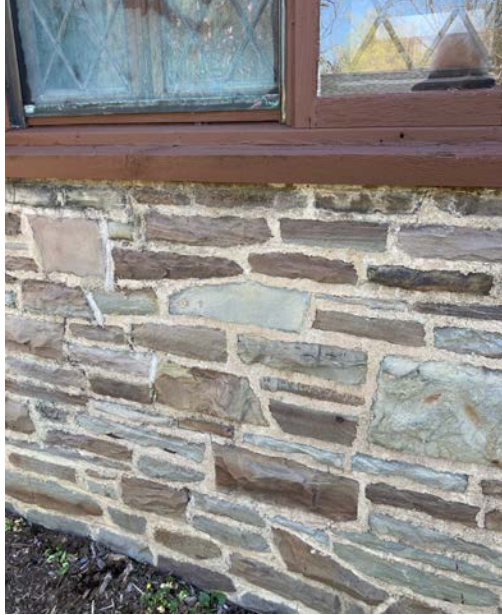
Rotting wood member, rusted copper window screen, efflorescence striations, biological growth on masonry, and small cracks in the mortar beneath the window on the northwest wall of Section C.

The stones directly beneath the window on the northwest wall of Section C are stained yellow from biological growth, likely exacerbated by the presence of a rotting wood member for the window sill. Below this row of stones, the stones have white striations from efflorescence, and there are several small cracks in the mortar.

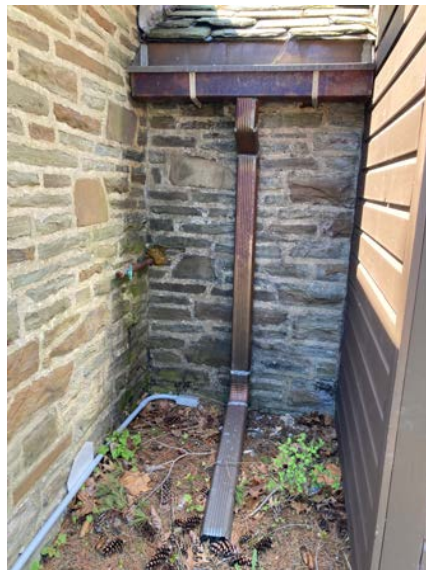
Moisture staining, biological growth, rust staining, efflorescence, and cracks in the mortar of the hyphen and Section F.

The darkened stones around the hyphen and its corner with Section F also have striations from efflorescence, bright green biological staining, and one large patch of rust-colored staining from a poorly-maintained metal pipe. There are also cracks in the mortar toward the bottom and at the top underneath the gutters; there appears to be missing material around the gutter straps, as well.

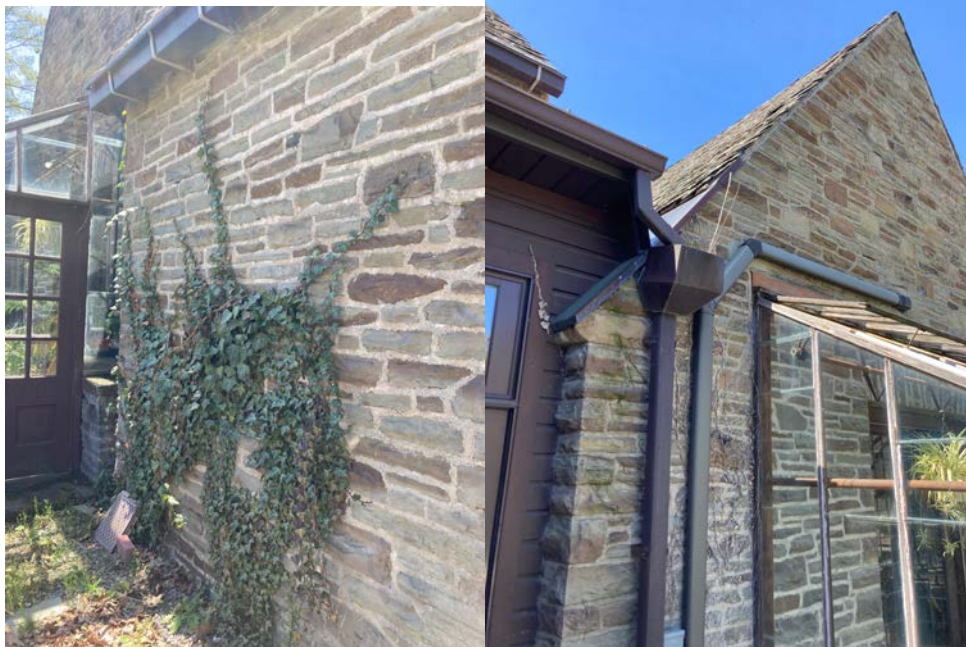
Vegetation growing along the northeast walls of Section C (L) and Section B (R).

The northeast wall of Section C has a large patch of ivy growing across it. Where the greenhouse attaches to Section B, there are the tendrils of ivies and other plants growing along the stone walls of B, as well as green biological material.

unintentionally damage the stone. Growing vegetation should be removed and care taken to prevent it from returning, especially on the northeast elevations of B and C. For areas heavily stained by efflorescence, poultices should be used to draw out the salts and diminish the effects of salt seeping and staining.

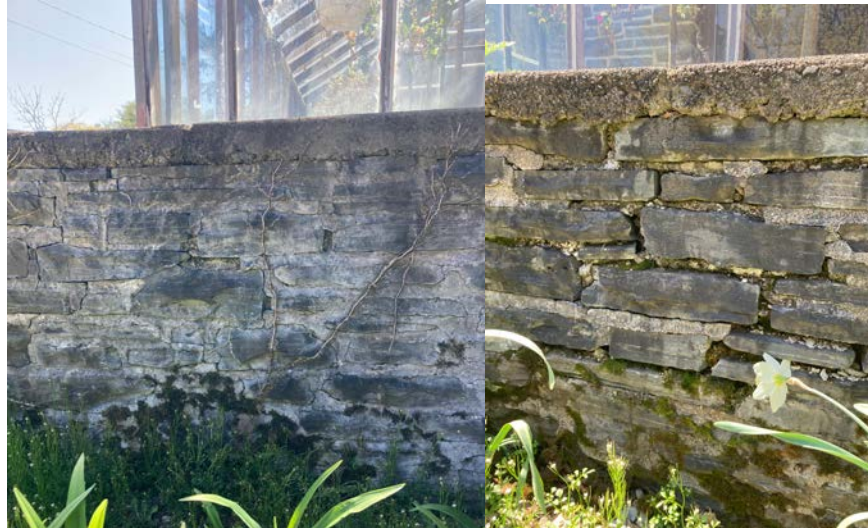
Poor condition of the stone half-walls of Section D.

The stone half-walls of the greenhouse, D, are in very poor condition. There is thick biological growth of moss found toward the base as well as the tendrils of plants causing cracks in the stone. The mortar is cracking and heavily deteriorated. The stones are chipped, stained dark from moisture and biological growth, and have white striations from efflorescence. The northeast wall has particularly bad staining and growth of yellow-green biological material, salt striations, and large chunks of missing or recessed mortar, so the stones appear to be loosely attached to the wall itself.

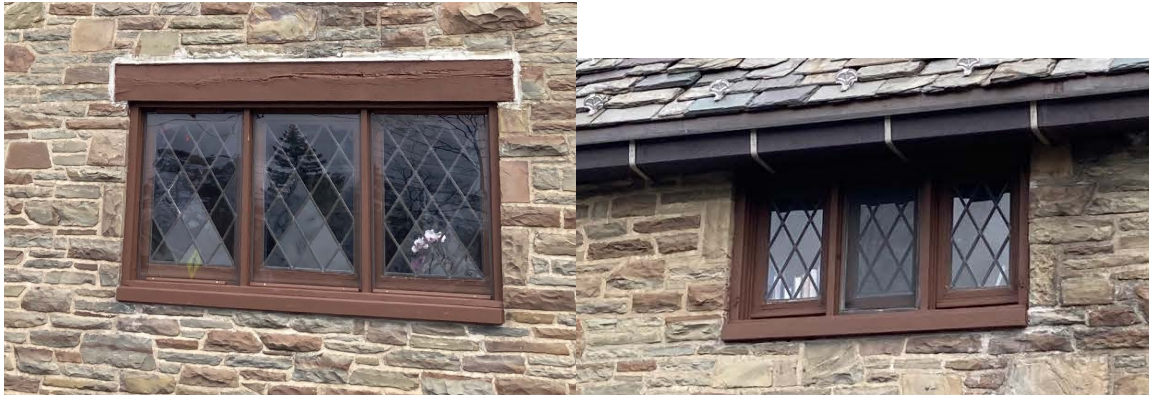
Easternmost windows on Section A's southwest elevation.

On Section A's southwest elevation, the lintel for the easternmost first story window has a large check spanning its length, and around the lintel the stones are discolored white, which may have been from caulking. Each sash has protective storm windows. There are no storms for the window above, but the center window is covered by a screen with a copper or copper-coated frame. The other windows and the door of the elevation are in good condition.

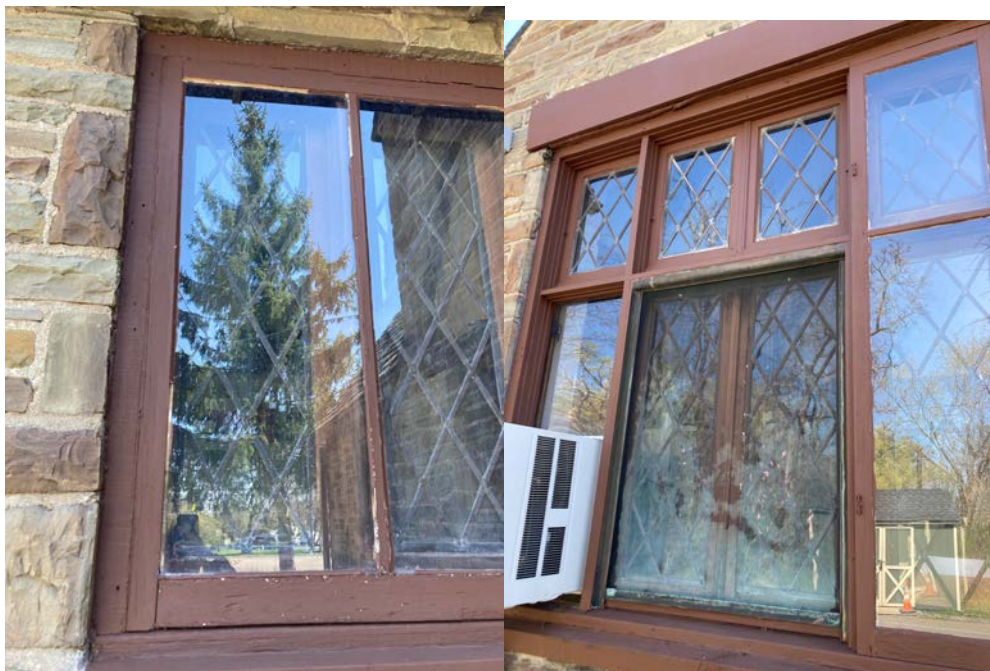
Broken storm window and paint chipping on the southwest elevation of Section C, and deterioration of the window on the northwest elevation.

There is a large crack in the leftmost storm window on the southwest elevation of Section C. Much of the paint for the wood frame of the window has chipped, exposing the wood underneath, and there are signs of checking. The wood framing and sill for the window on the northwest wall of Section C has not yet been replaced or repaired, and is heavily deteriorated, with wood rot that has eaten away at the interior and created large hollow pockets. The copper window screen is rusted and covered in grime. Only the rightmost windows have storms. The lead casement windows have rust staining, and there is some chipping of paint around the wood frames.

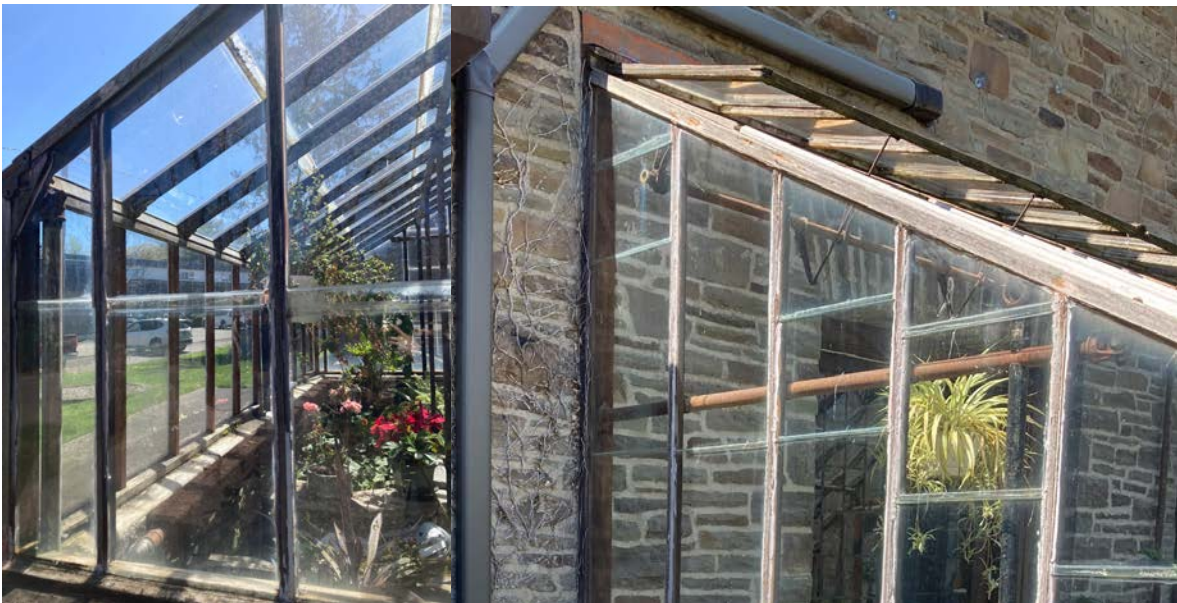
Deterioration of wood members (L) and rusting of the metal (R) around the greenhouse.

The windowed walls and roof of the greenhouse have had some wood members replaced with newer ones, but the majority have not been replaced and are in generally poor condition with signs of rot, cracking, and checking. There is a lot of caulking along many of the members that has seeped onto the glass. Some of the glass panes have been replaced by plexiglass. The metal brackets at the corner of the glass wall with the glass roof have rust, and there is metal

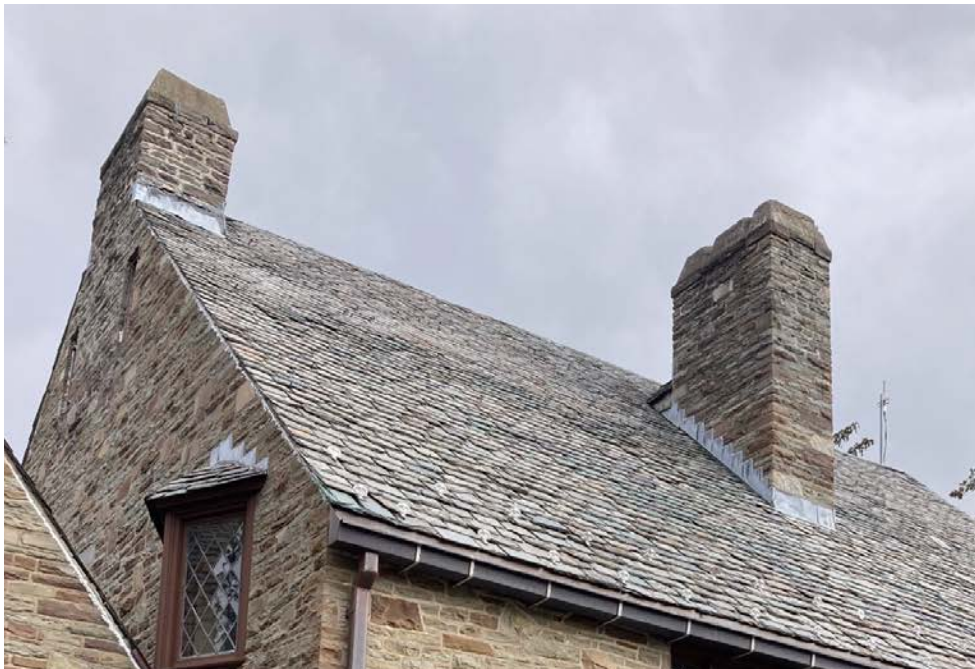
Crazing, spalling, and leaching in the chimneys of Section A, and incompatible mortar in the masonry.

The center chimney of Section A's concrete chimney caps shows signs of crazing and spalling off at corners. There are also many large white veins in the concrete from salt leaching. The cap of the chimney on Section A's northwest wall shows similar deterioration patterns, but not to as extreme an extent. There are cracks in the mortar of the chimney on the northwest wall of Section A, which may suggest movement. The chimney between B and C has veins from salt leaching as well, alongside large cracks and spalling.

The chimneys are not in use but are not capped off either, which leads to rain infiltration and moisture problems inside the chimneys and along the walls where the chimneys lead. Since chimneys experience more temperature extremes, the stones of the chimneys appear in generally

worse condition than the stones of the house itself, with dark staining and mortar that has been repointed inadequately or with incompatible material, creating a jarring, uneven appearance.

Some stones appear to be bulging slightly from the chimney.

The flues of the chimneys should be sealed off to prevent further air and moisture circulation in and out.

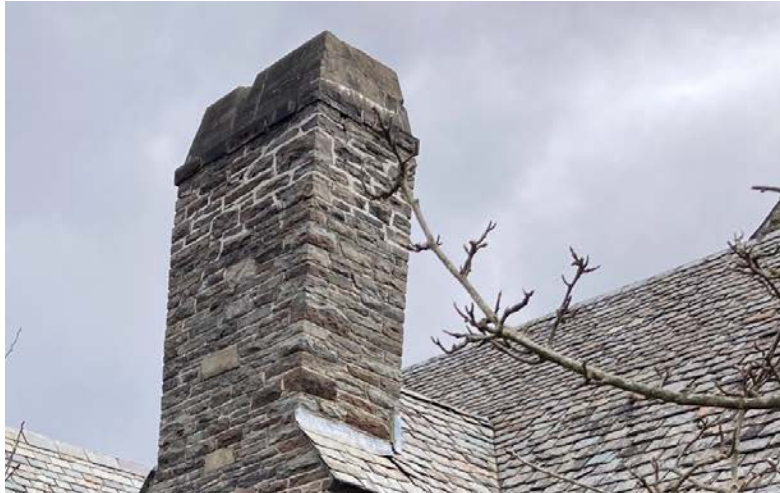
Deterioration of the upper part of the chimney between B and C.

The chimney between B and C has the worst stone deterioration, particularly toward the top where there are large swaths of incompatible replacement mortar and dark-stained stones, and toward the bottom underneath the stone coping slab. The combination of the sloping gable roof which leads down to the slab and the gutter of Section B that leads has caused severe moisture damage where the base of the chimney projects from the wall, with very dark staining, alongside large chunks of mortar missing, and many loose mortars and bits of stone. There is a huge crack in the center of the chimney with multiple smaller cracklers, suggesting movement. There are also striations on the stone from efflorescence.<sup>14</sup>

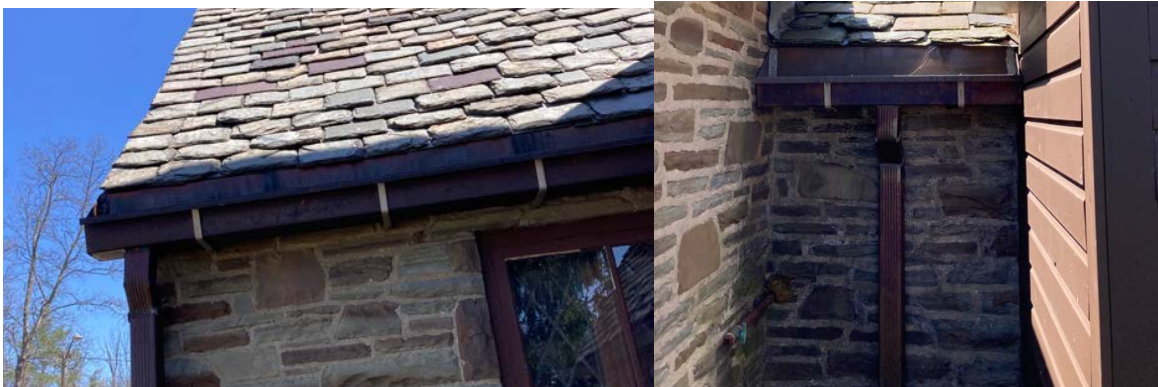
Rusted gutters around Section C and the hyphen.

Since the copper gutters and drainpipes have been installed within the last several years, they are in generally good condition. There is some rust on the copper gutters around C and on the gutter and drainage pipe below the northeast slope of the hyphen between A and F.

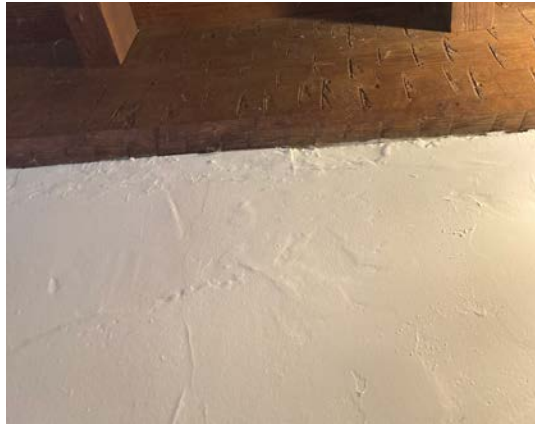
Bubbling and chipping of the plaster where it meets the wood member in the lobby.

The building has been struggling with moisture infiltration from outside, which has resulted in issues of bubbling plaster around the interior. Some of the worst bubbling and water damage inside the Village Court has been repaired with new plastering. There is still some bubbling and plaster chipping around locations where the plaster meets wood members in the lobby. The walls have been repainted within the past few years.

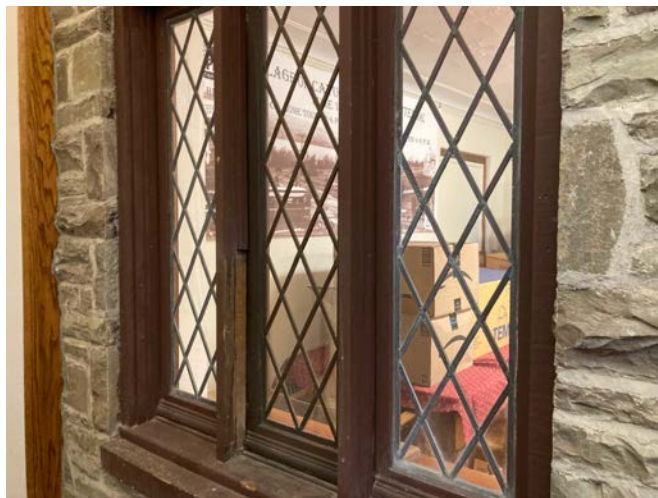
Chipping and wear on the original exterior windows outside the Jury Room.

The original exterior wall to the northeast has windows with old and chipped wood frames, sills, and lintels, with some paint coming off as well.

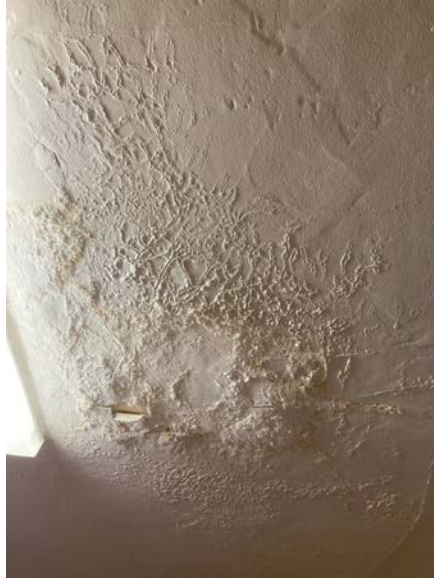
Severe plaster damage on the Jury Room ceiling.

The plaster on the ceilings is for the most part in good condition, except for the Jury Room, where bathrooms directly overhead on the second floor have led to substantial moisture damage for the plaster, leading to bulging and bubbling.

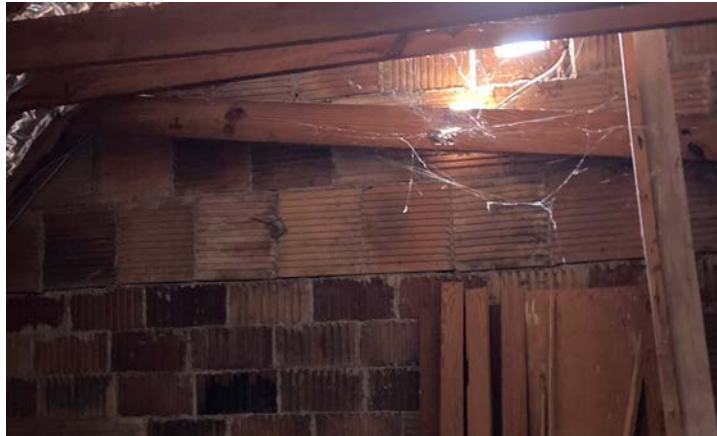
Downward movement in the center of the wall, and subpar mortar quality.

There is some downward motion in the coursing of the hollow clay tile in the center of the southeast gabled wall, though it is unclear whether this is the result of movement or whether it was built in that way. The mortar quality for the clay tiles in the attic is subpar and deteriorating.

stone around the fireplace in the attic should also be examined for signs of structural instability. Patching repairs using cementitious materials may also be used here to fill in this crack. The downward motion of the gable end in the unfinished section of the attic should be investigated, tracked and measured for any further movement.

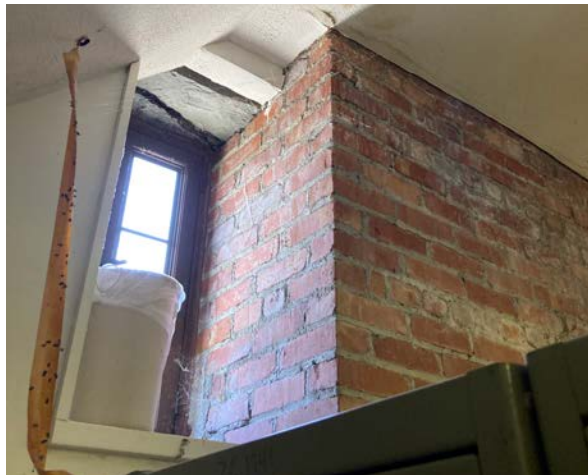
Chimney and window in the finished half of the attic.

The chimney in the finished half of the attic has eroding bricks and mortar, and the stone above its windows has a huge crack.

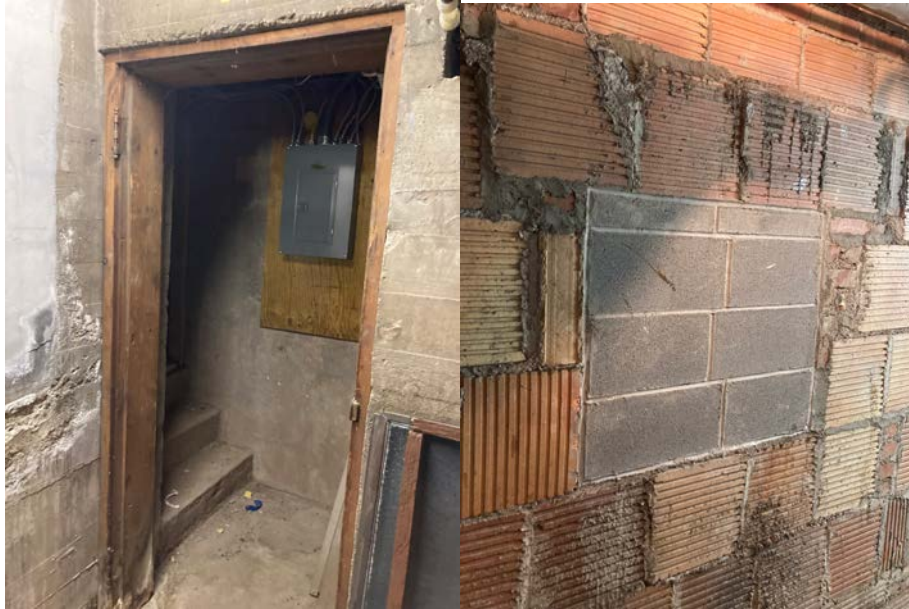
Deteriorated concrete in the basement (L) and clay tiles with leaking mortar (R).

According to the Village Clerk, there are no structural concerns with the foundation, though the clay tiles in the basement are clearly aged with some deteriorated or missing pieces of mortar, and some tiles appearing slightly askew or slanted. The concrete sections of the basement show signs of crazing and scaling.

Given the lack of any major structural concerns and only minor condition concerns with the state of the clay tiles, concrete, and bricks in the basement, it does not appear necessary to do any intensive testing on the condition of the materials.
