1. ORIGINAL SURVEY MAP COMPLETED BY TG MILLER ON 12/19/12 WAS ADOPTED AND CONTROL POINTS #1 AND #2 WERE RECOVERED ON 9/14/18. FEATURES WERE MAPPED USING A TOTAL STATION.
2. EDGE OF STREAM BANK WAS THE POINT OF INFLECTION BETWEEN THE STREAM BANK AND ADJACENT FLAT SLOPE
3. SCALE 1"=20' ON HALF SHEET PRINT SIZE.

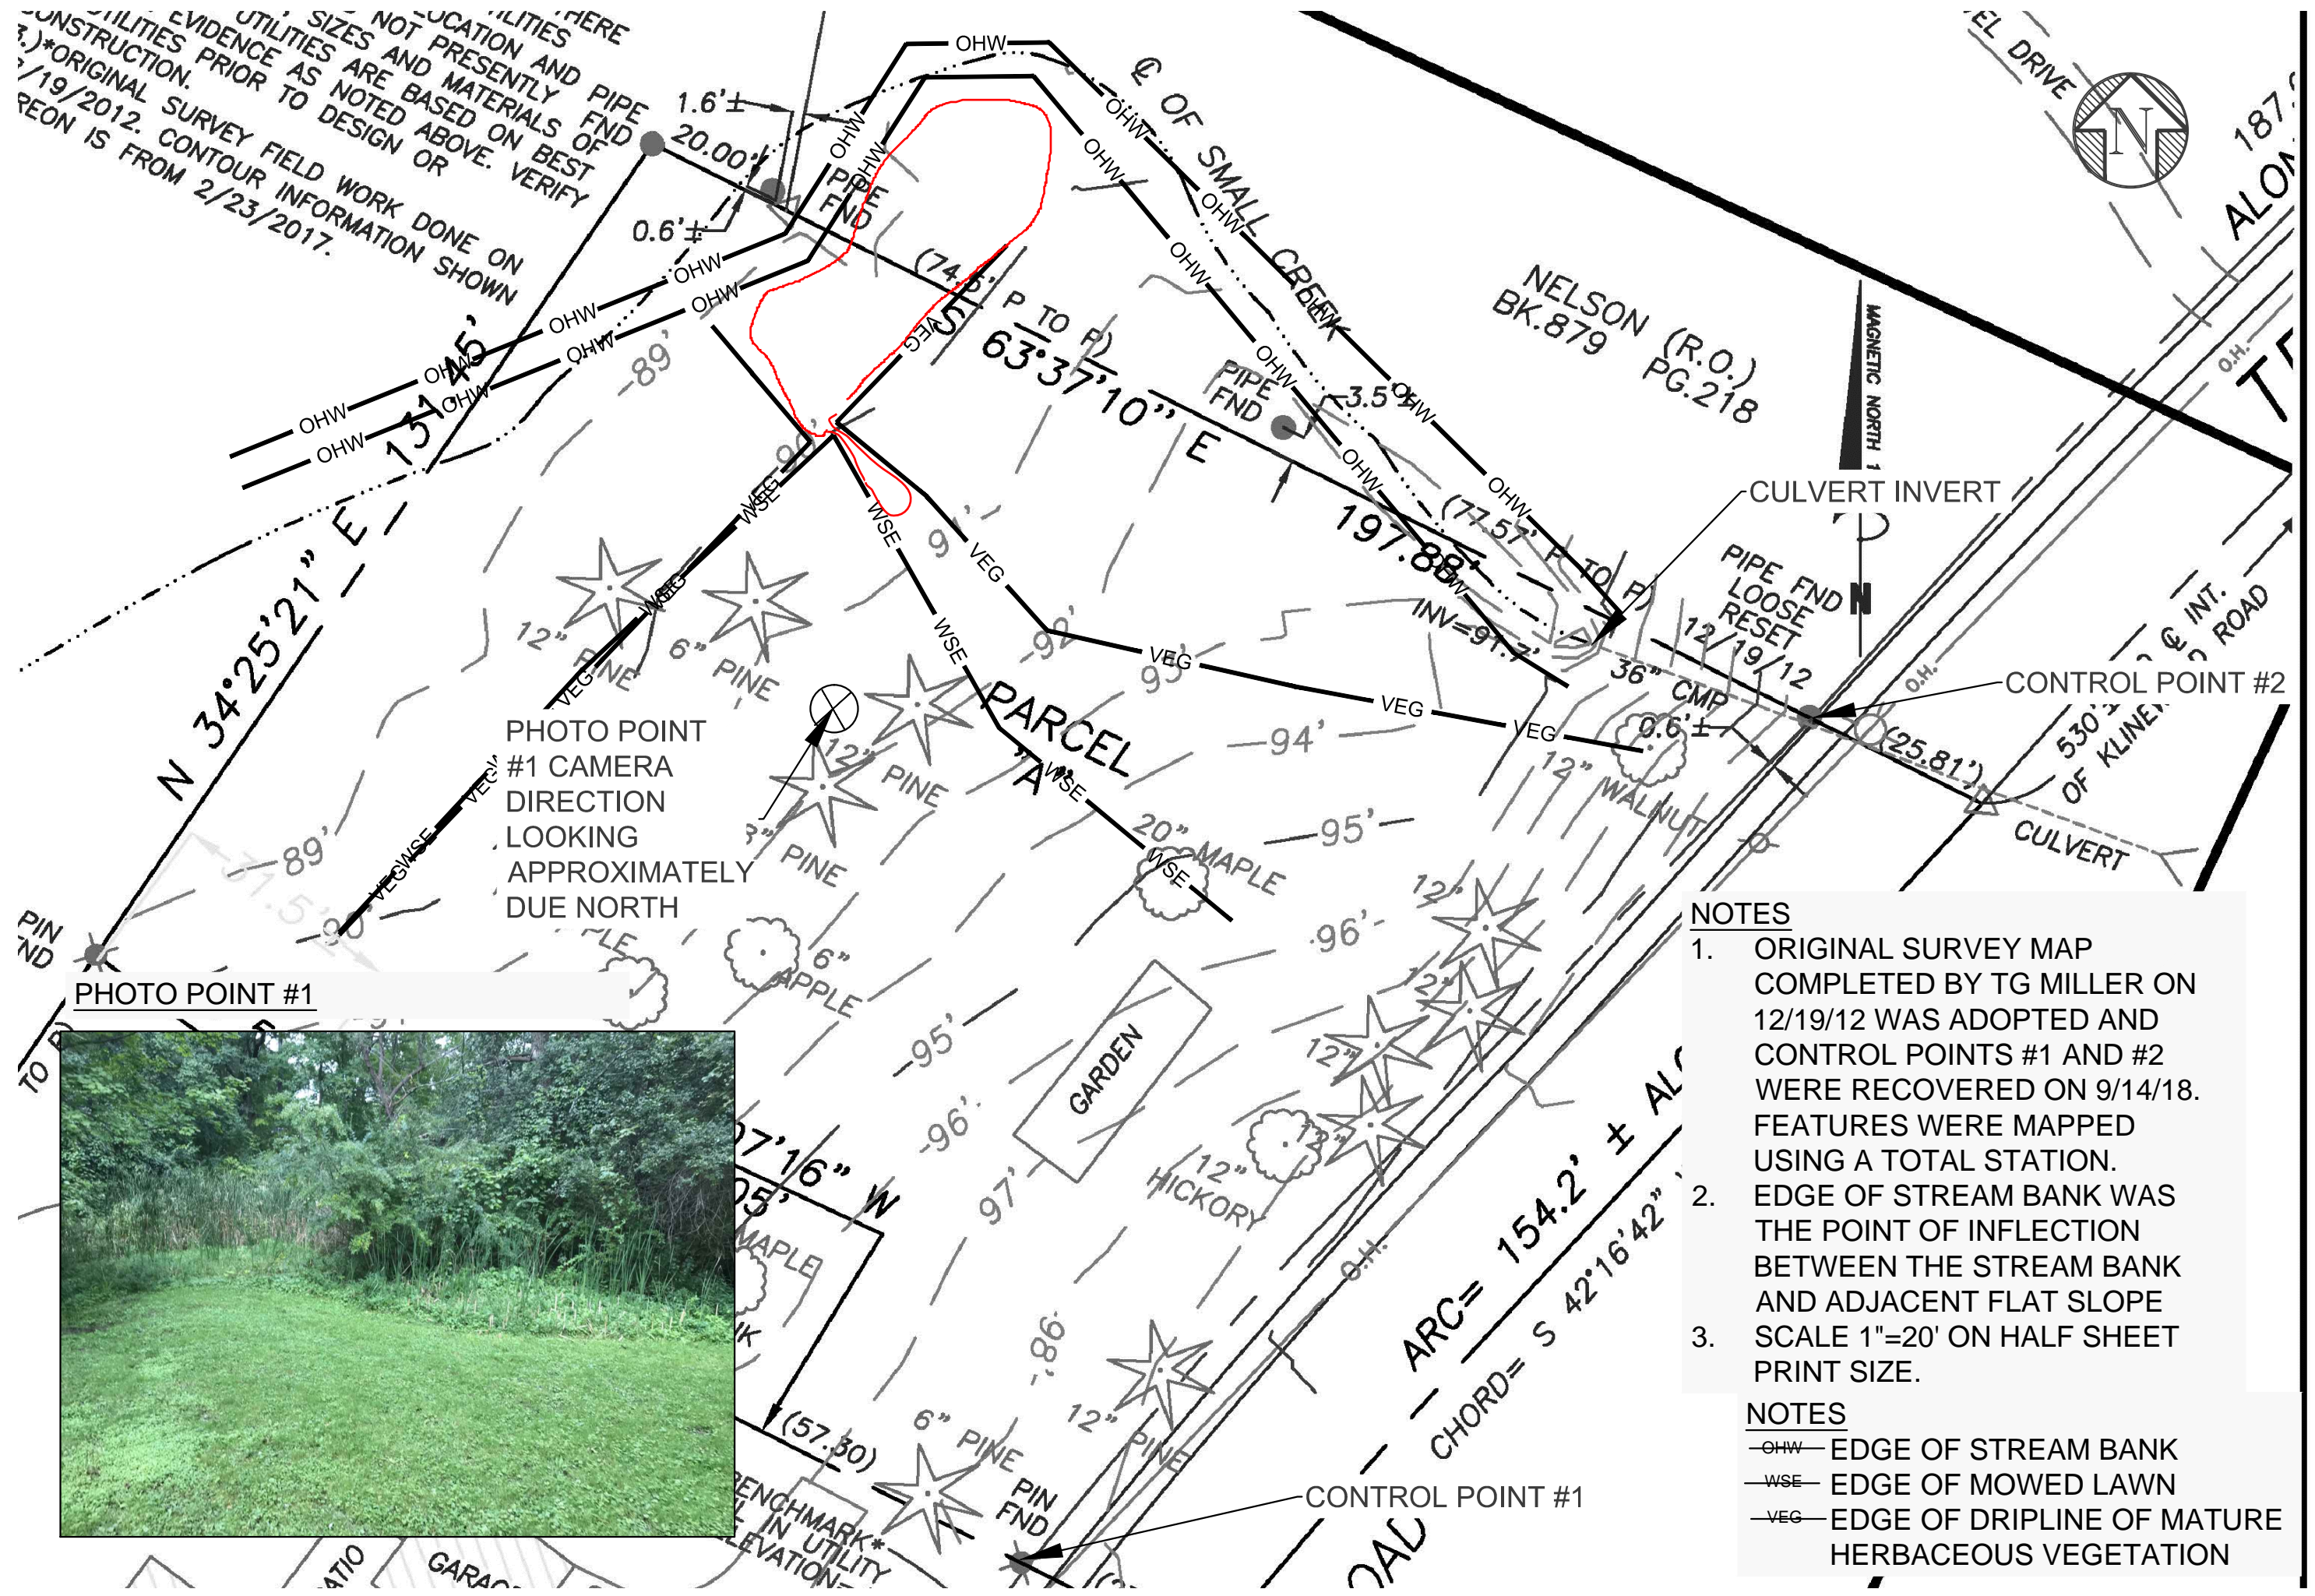
LOCATIONS AND MATERIALS FOUND HERE  
 UTILITIES ARE BASED ON BEST  
 EVIDENCE AS NOTED ABOVE. VERIFY  
 CONSTRUCTION. CONTOUR INFORMATION SHOWN  
 ORIGINAL SURVEY FIELD WORK DONE ON  
 12/19/2012. CONTOUR INFORMATION SHOWN  
 ORIGINAL IS FROM 2/23/2017.

- OHW- EDGE OF STREAM BANK
- WSE- EDGE OF MOWED LAWN
- VEG- EDGE OF DRIPLINE OF MATURE HERBACEOUS VEGETATION

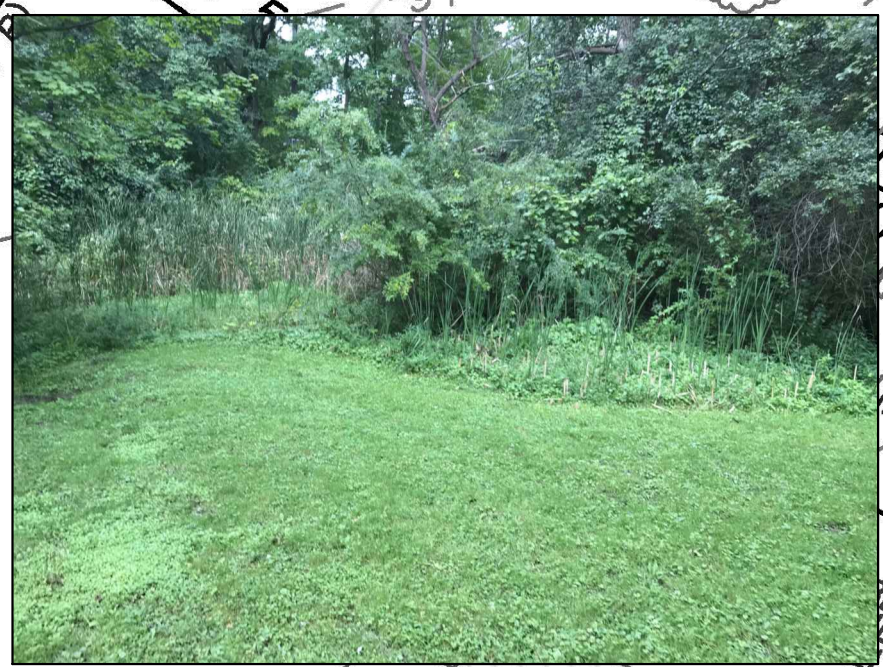
PHOTO POINT #1 CAMERA DIRECTION LOOKING APPROXIMATELY DUE NORTH
